# Applying the Build Back Better strategy to sewage facilities (Minami-Gamo Wastewater Treatment Plant)

5 Features of the new facility (Minami-Gamo Wastewater Treatment Plant)  
(Budget: approx.64.7 billion yen)

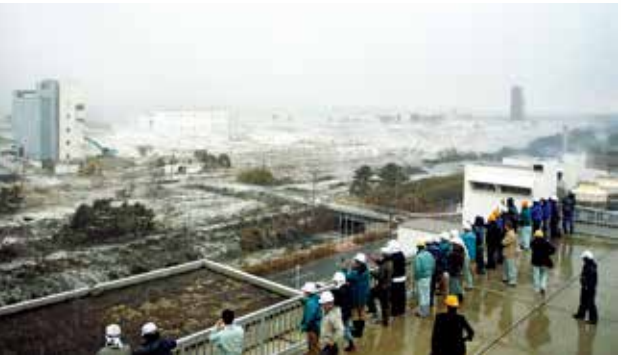
▲ Minami-Gamo Wastewater Treatment Plant being engulfed by the tsunami (March 11, 2011)

At Minami-Gamo Wastewater Treatment Plant, which suffered particularly severe damage, most of the facilities were submerged by the tsunami, but all 101 personnel who were working at the plant when the tsunami hit evacuated to the roof of the administration building and were rescued by helicopter the following day.

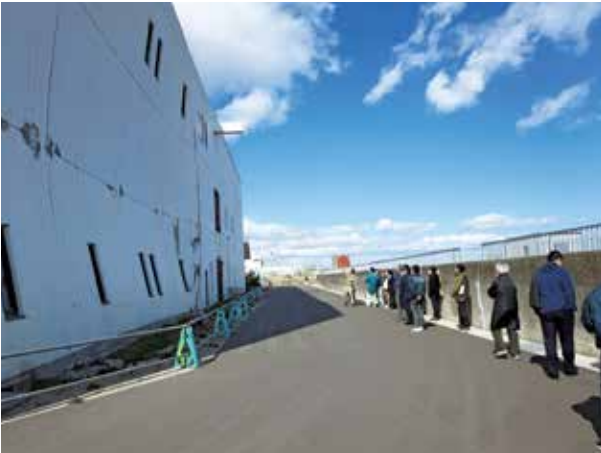
▲ Pumping Station No.3 at Minami-Gamo Wastewater Treatment Plant, which was distorted

At Minami-Gamo Wastewater Treatment Plant, lessons learned from the earthquake disaster are being shared with visitors through videos showing the situation when the tsunami hit and the process from the formulation of the restoration policy to implementation of restoration works, and a tour of pumping station No. 3, which was distorted by the tsunami.
